GENERAL HEALTH & SAFETY RISK ASSESSMENT

Hughenden Court, Mount Pleasant Road Hastings, East Sussex TN34 3ST

Prepared By: Henry Fuller TechIOSH

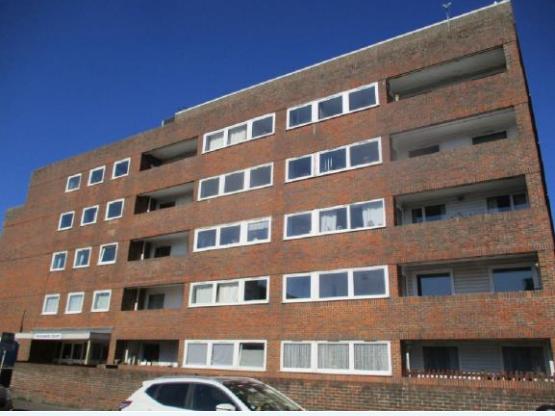
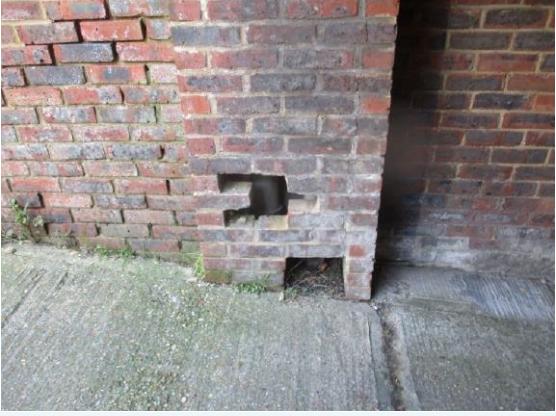
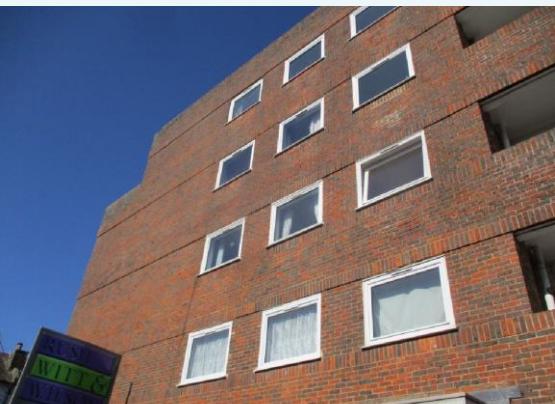
Risk Item	Status	Risk Rating
Is the building subject to regular/periodic inspections by a suitably qualified surveyor	Controlled	Tolerable

A survey has been undertaken and immediate repairs have been undertaken. A 10 year plan is in place to deal with the remaining issues.

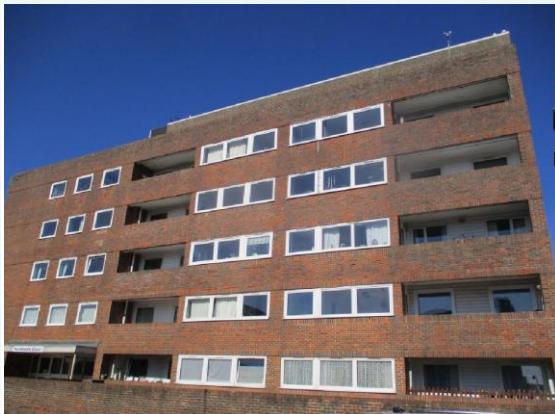
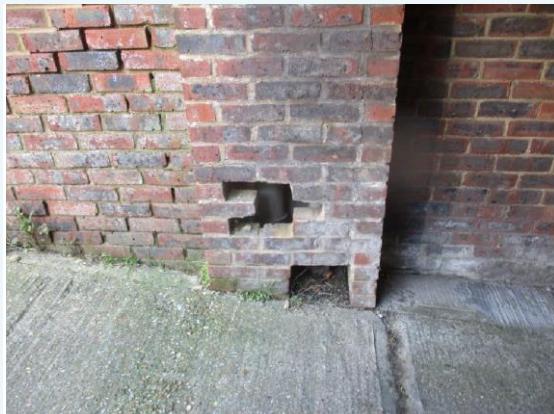
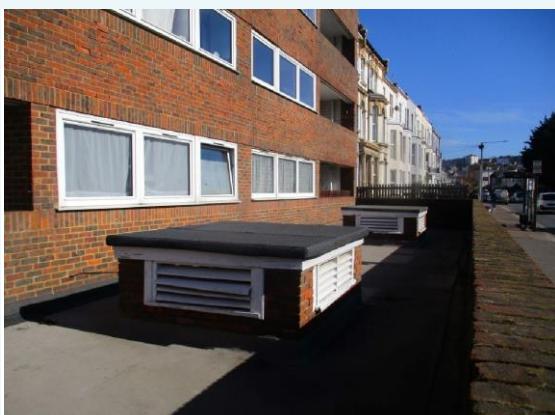
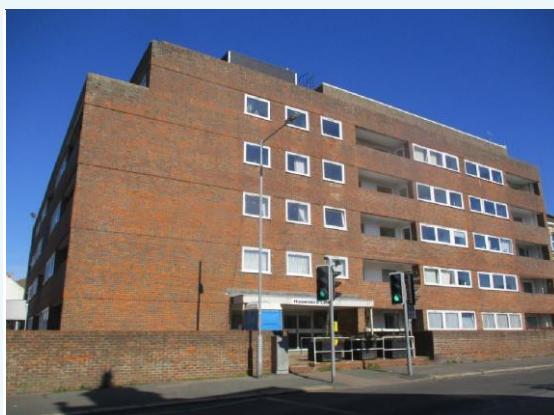
Does the building exterior appear to be in reasonable state of repair

Uncontrolled

Moderate

Upon ground level visual inspection, the building appears to be in poor condition, with several areas of damage observed. A survey has been undertaken and immediate repairs have been undertaken to deal with safety issues. A 10 year plan is in place to fully complete the actions identified during the survey.

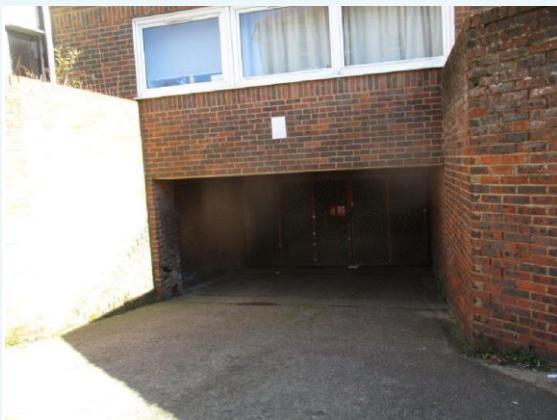
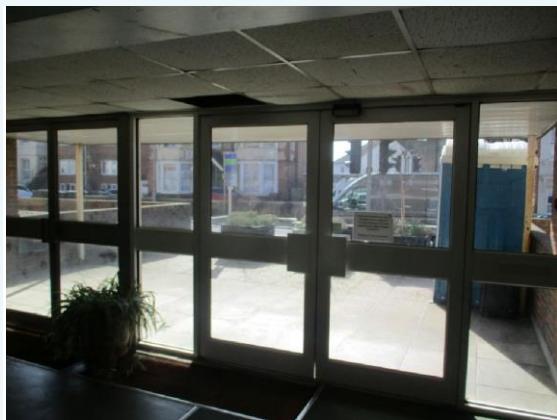
Risk Item	Status	Risk Rating
Does the building appear to be secure against unauthorised access	Controlled	Tolerable

The building is secure with a key entry system for residents and an intercom system for visitors. Access to the car park is restricted via keys.

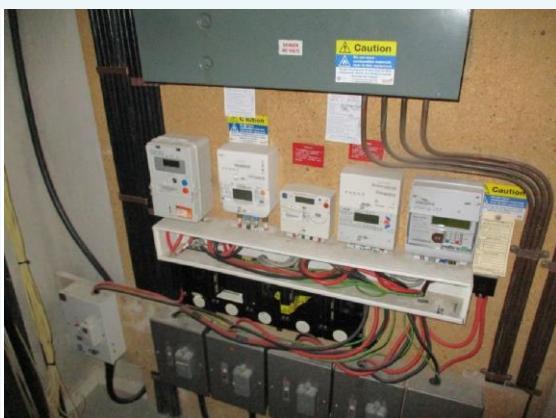
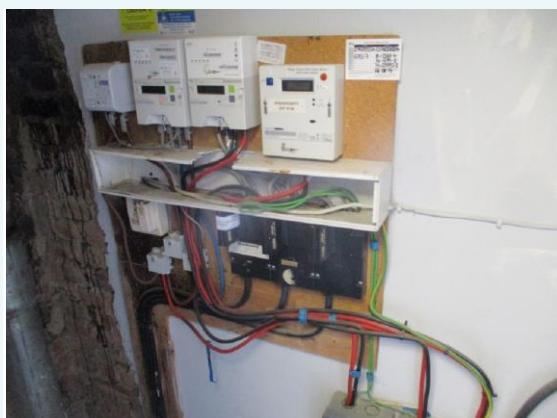
Risk Item	Status	Risk Rating
Does it appear that electrical distribution is free from physical damage	Controlled	Tolerable

Upon visual inspection, no damage or issues were observed at the time of this assessment.

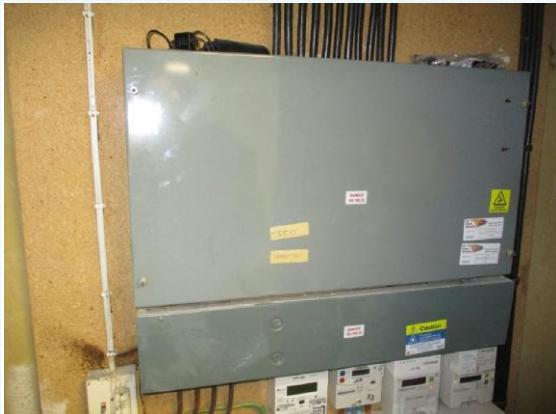
Has the main electrical distribution been subject to a formal inspection by a competent electrical contractor in the last 5 years	Controlled	Tolerable
---	------------	-----------

The client has confirmed that the last fixed wiring inspection was undertaken 09/10/2023.

It is recommended that inspections are undertaken every 5 years.

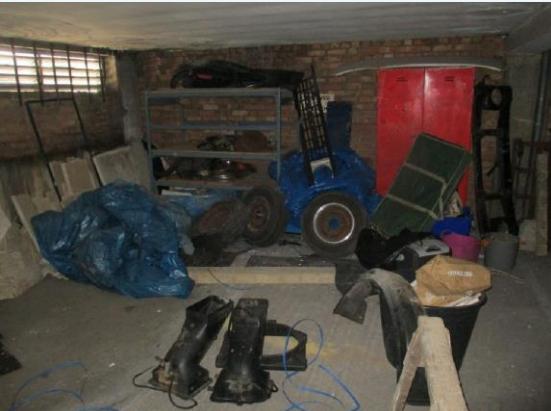
Risk Item	Status	Risk Rating
Are standards of housekeeping reasonable

Uncontrolled	Moderate

At the time of this assessment there was a reasonable standard of housekeeping throughout the property. The internal areas should be kept clear of potential trip hazards and combustibles.

At the time of this assessment the car was used by residents for storage. It is recommended that the car park kept free and clear of combustibles and obstructions.

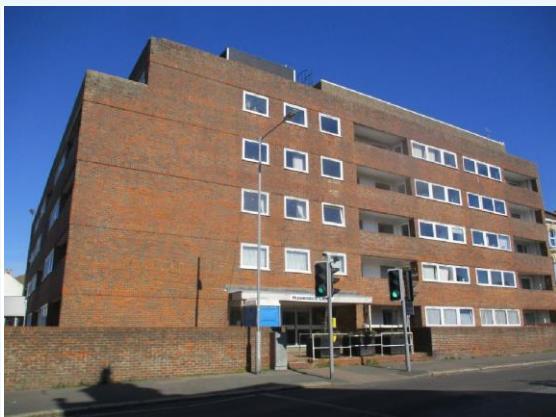
Risk Item	Status	Risk Rating
Does the client have an asbestos survey/report for this property	Controlled	Tolerable

An asbestos survey has been undertaken.

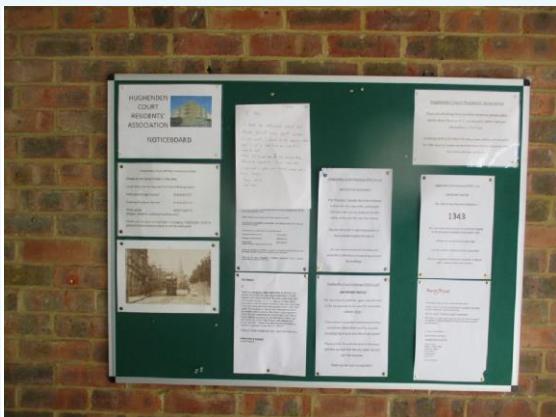
Risk Item	Status	Risk Rating
Does the client have a cleaning contract in place for the common areas	Controlled	Tolerable

The client has confirmed that a cleaning contract is in place for the property.

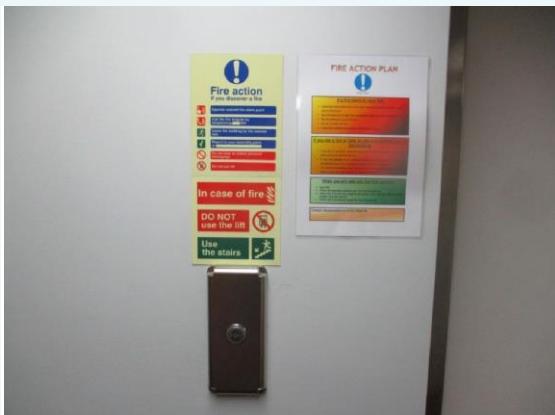
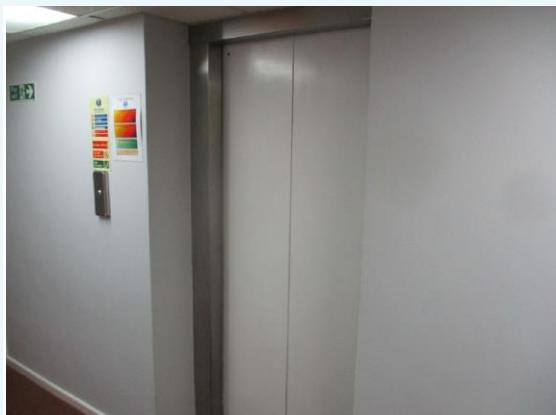
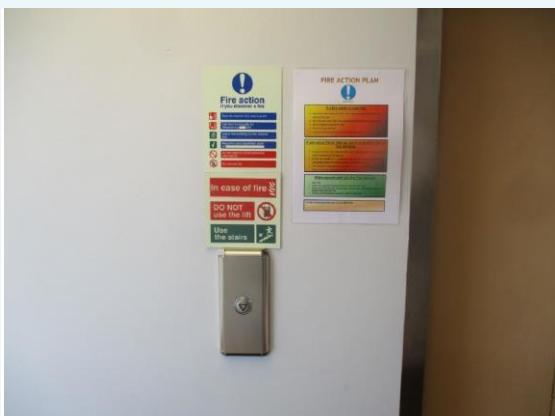
Risk Item	Status	Risk Rating
Is signage displayed indicating lift not to be used in case of fire	Controlled	Tolerable

Suitable signage is displayed.

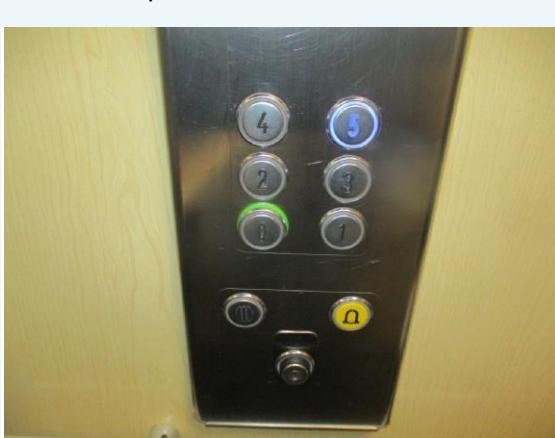
Is the lift car provided with a communication system	Controlled	Tolerable

An alarm is provided but no communication system. Residents are aware that there is no lift communication alarm. Mobile phones receive a signal within the lift.

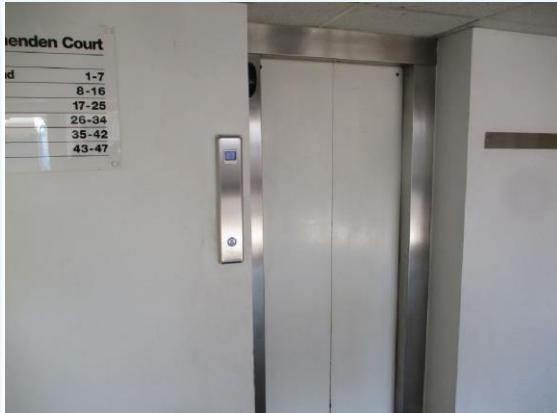
Risk Item	Status	Risk Rating
Is the lift subject to 6 monthly thorough examinations as required by The Lifting Operations and Lifting Equipment Regulations 1998	Controlled	Tolerable

The lift was last thoroughly examined 01/10/2024, there were no issues identified.

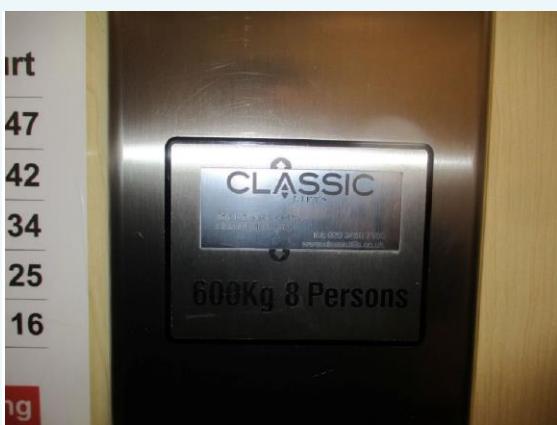
Risk Item	Status	Risk Rating
Is the lift car capacity displayed	Controlled	Tolerable

The lift capacity is displayed, and set at 8 persons / 600KG.

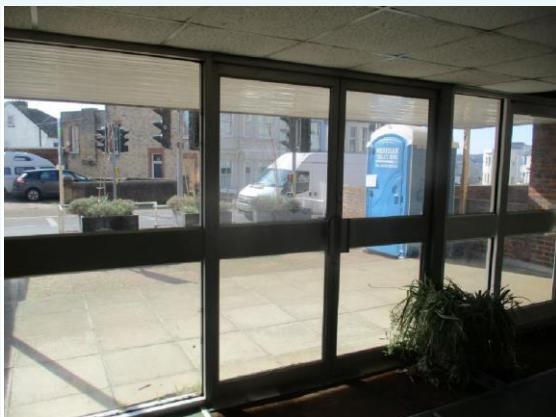
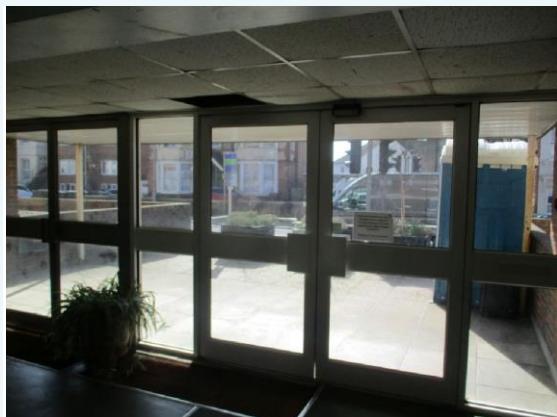
Risk Item	Status	Risk Rating
Where glazing is installed on pedestrian traffic routes does it appear to be safety glazing	Controlled	Tolerable

The glass in the main entrance is double glazed.

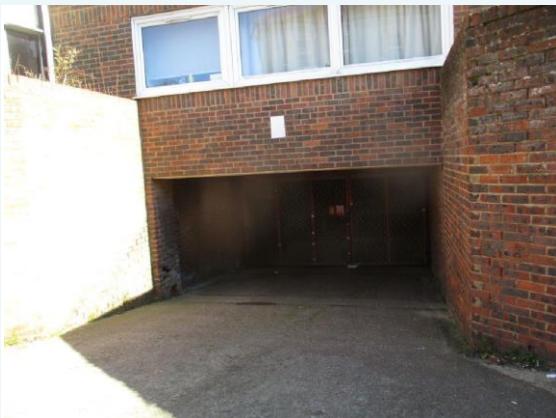
Risk Item	Status	Risk Rating
Does the client have arrangements in place for gritting pedestrian traffic routes during cold, inclement weather when there is a risk of ice/snow	Controlled	Tolerable

The vehicle access ramp is secluded and the property is located near the sea, the risk of snow and ice is low.

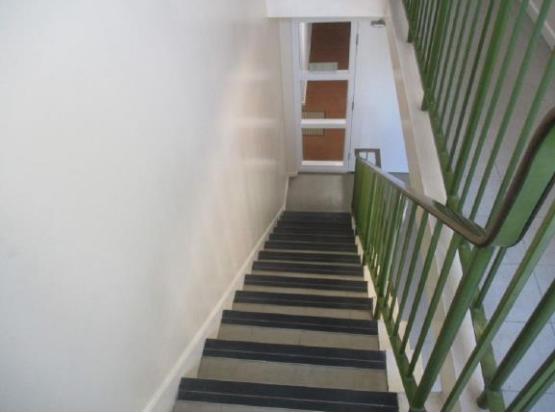
Are staircases and changes of level provided with handrails where necessary	Controlled	Tolerable
<p>

A photograph showing a staircase with dark treads and a light-colored wall. A handrail is visible on the right side of the stairs.</p> <p><i>All staircases and changes of levels have suitable handrails.</i></p> <p><i>See action regarding the handrail at the entrance to the building.</i></p>

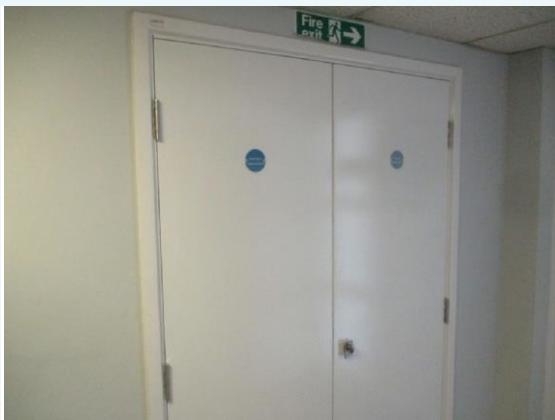
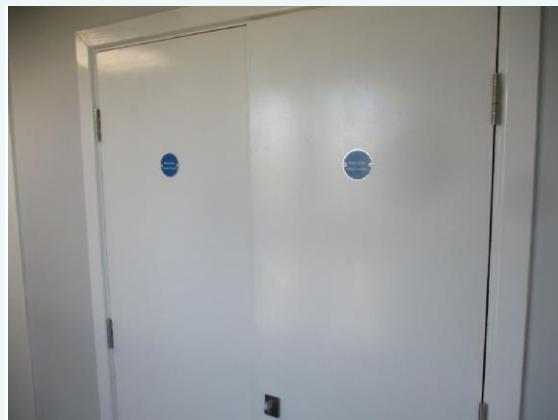
Risk Item	Status	Risk Rating
Are plant rooms maintained locked against unauthorised access	Controlled	Tolerable

A number of plant rooms were found to be unlocked due to ongoing fire door works at the property. Arrangements are in place to ensure that plant rooms and risers are kept locked.

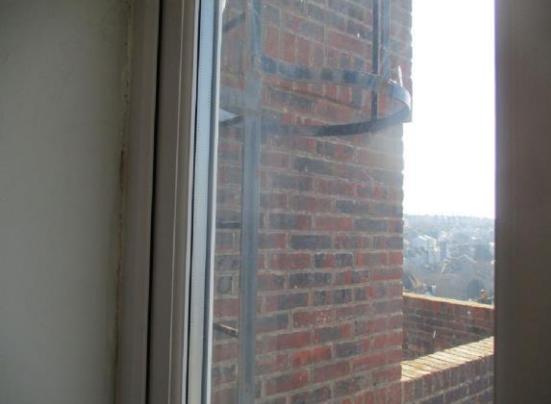
Risk Item	Status	Risk Rating
Is access to the roof limited to authorised persons

Uncontrolled	Moderate

A fixed ladder is located on the roof and could not be accessed at the time of this assessment. It is understood that some residents have access to this area.

It is recommended that the client installs a ladder plate to restrict unauthorised access to this area.

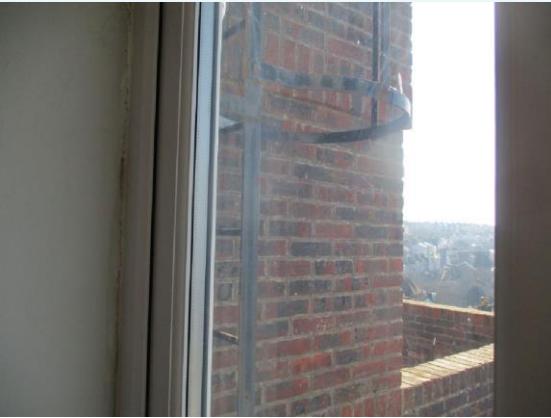
Risk Item	Status	Risk Rating
Are all ladders subject to regular inspections

A fixed ladder is located on the roof and could not be accessed at the time of this assessment.

No evidence of inspection was provided at the time of this assessment. It is recommended that ladders are subject to regular inspections.

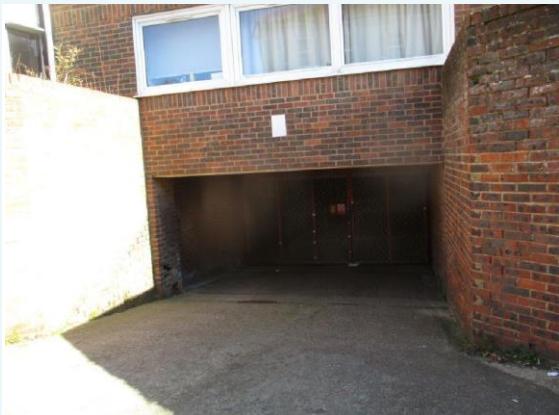
Risk Item	Status	Risk Rating
Where overhead height restrictions apply is suitable signage displayed	Uncontrolled	Moderate

It is recommended that signage is installed above the entrance to the carpark.

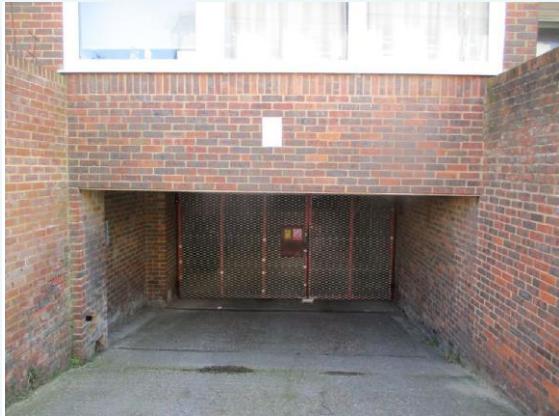
Risk Item	Status	Risk Rating
Can the site gates be secured in the open position	Controlled	Tolerable

The car park gates can be secured when in the open position.
